Skokie River Streambank Stabilization Project

Chris Hanchett, P.E., CFM, CPESC

EAST SKOKIE DRAINAGE DISTRICT

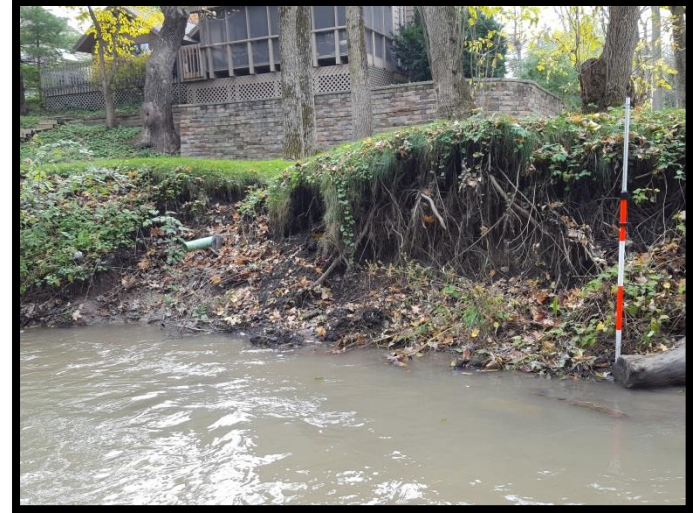
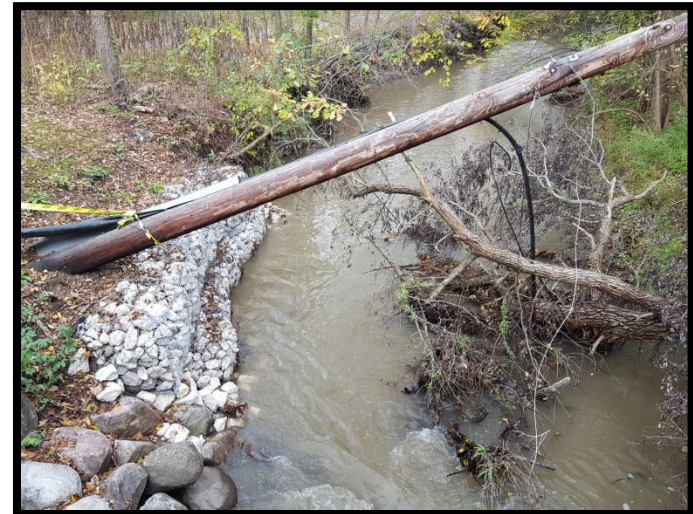
- Property Loss (\$\$)
- Loss of trees and vegetation along the river edge (loss of habitat)
- Existing utility poles and storm sewer outfalls are at risk of failure

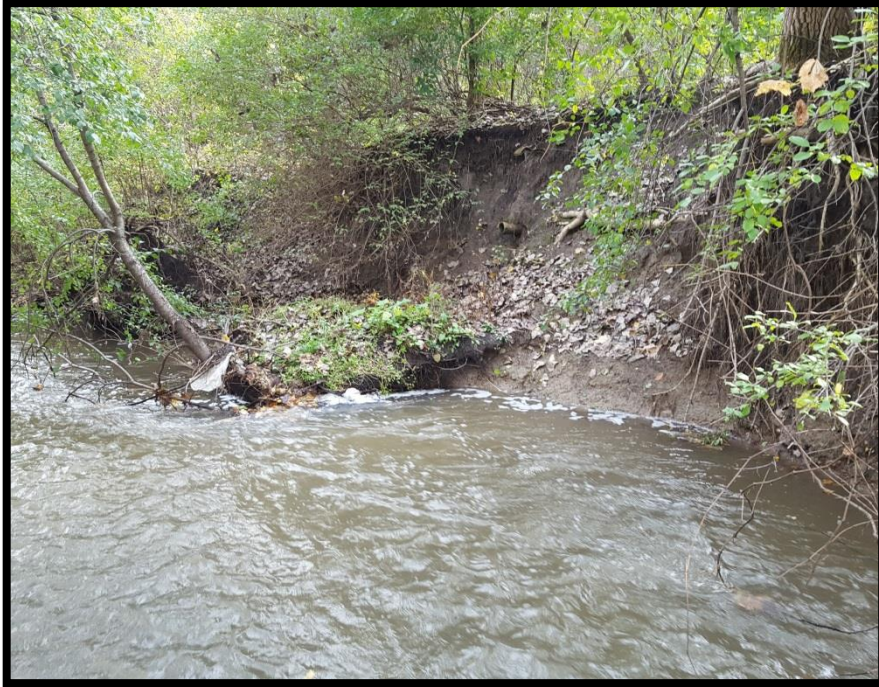
November 2016

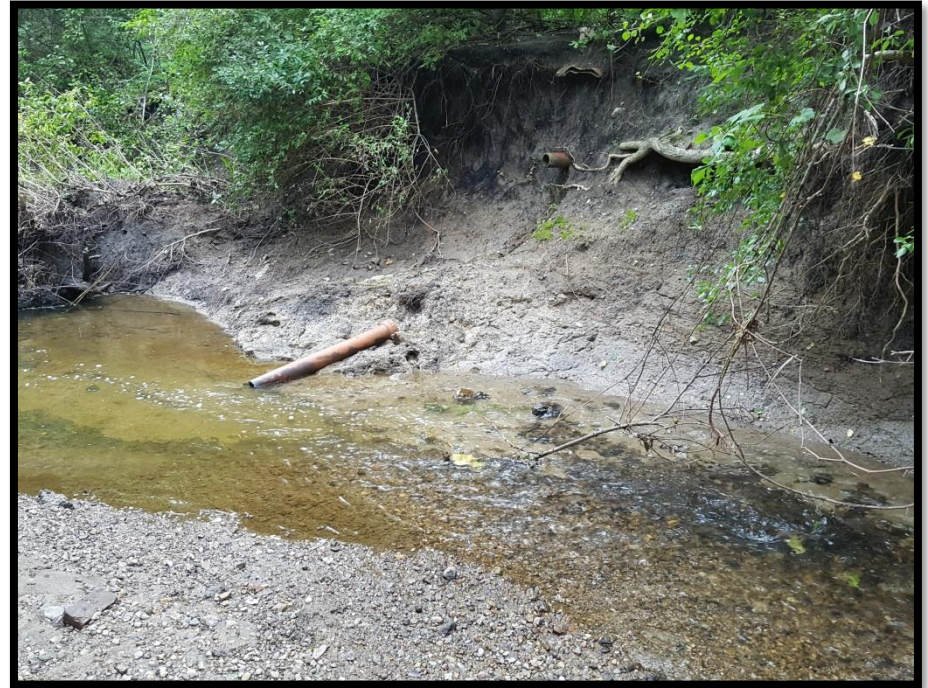
After July 2017 Storm Event

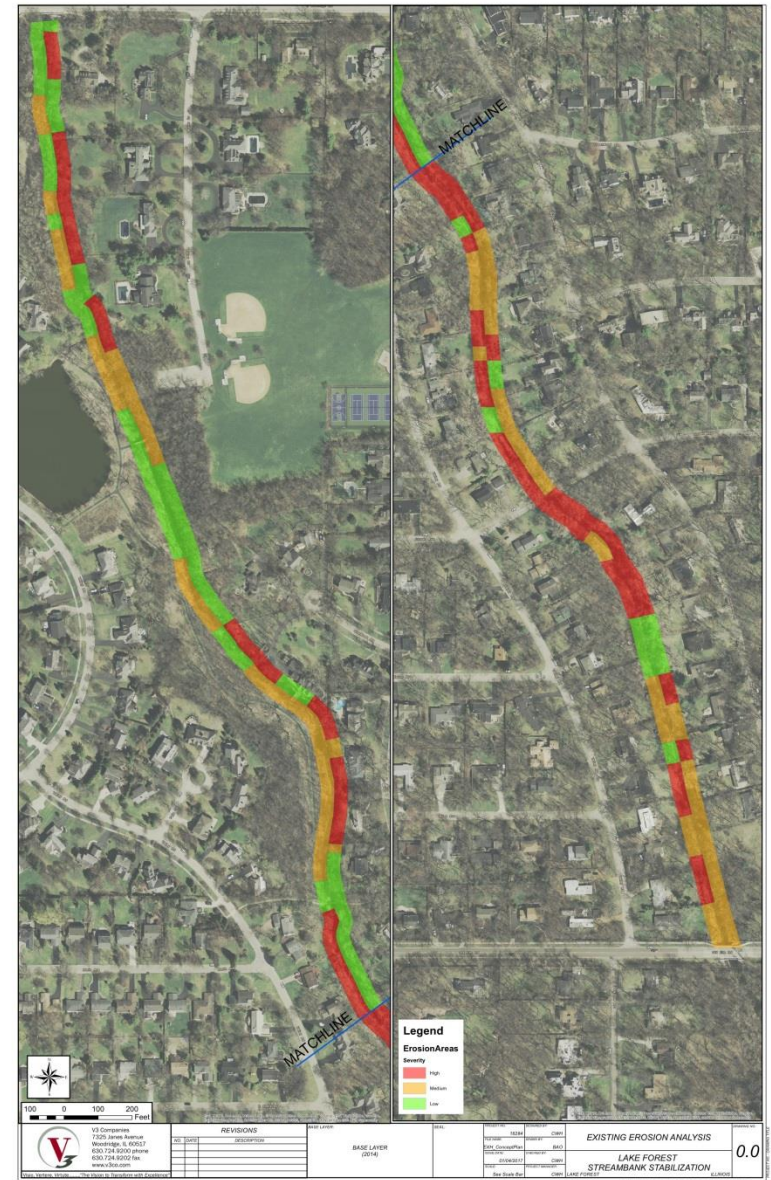
Existing Erosion Analysis

- V3 developed an exhibit that identified the existing erosion along the river and categorized it based on severity.
 - Low (Green)

- Medium (Orange)

- High (Red)

- This analysis was used as the basis for the conceptual and preliminary bank stabilization designs.

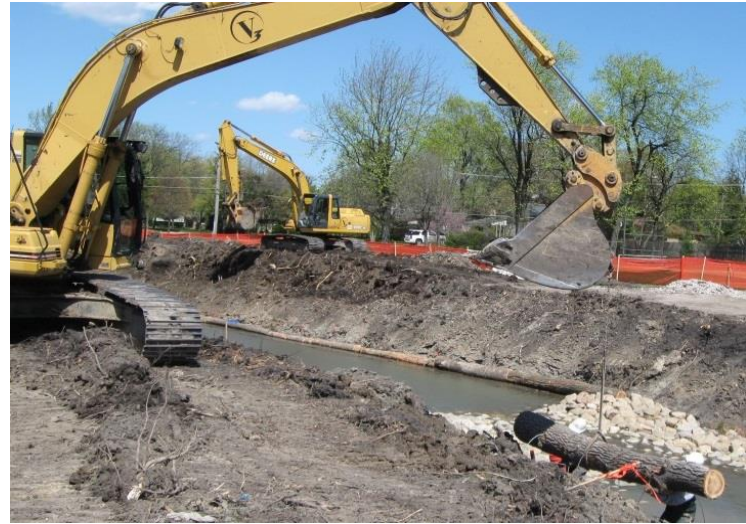
- *Fallen trees or natural logs can be used to provide an aesthetic toe protection feature.*
- *Size of the logs vary in size depending on the severity and height of the erosion*
- *Only minor grading above the toe protection is needed*
- *Can be used on areas with erosion heights less than 2 feet (due to log size)*
- *Can re-use trunks of trees that are removed as part of the project.*

During Construction

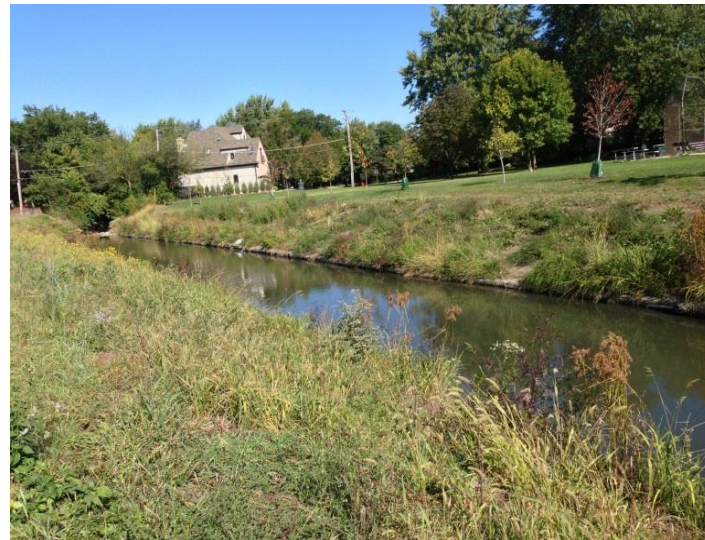
Post Construction with Vegetation

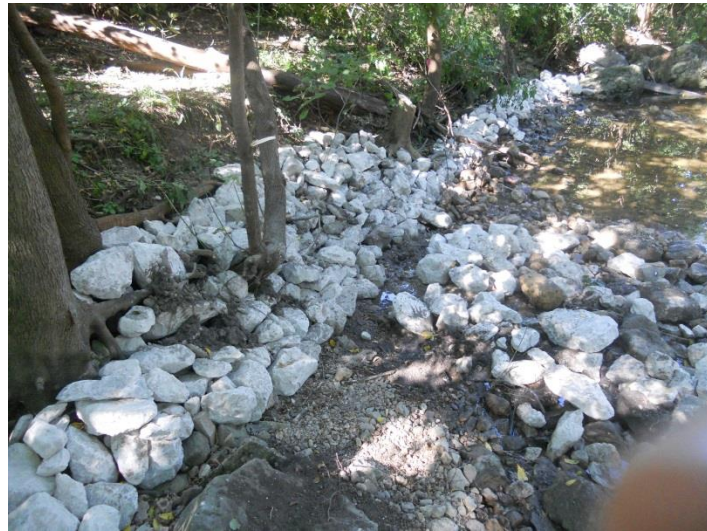
- *Stone will be place on and toed into bank to prevent further erosion of the bank*
- *Only minor grading above the toe protection is needed*
- *Can be used on areas with erosion heights less than 3 feet and high velocity areas*
- *Longer service life than logs*

Stone Toe Protection on Wooded Banks

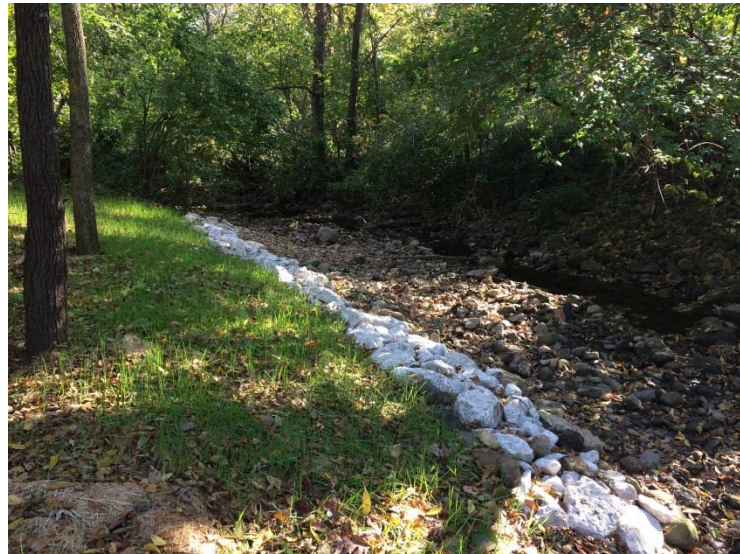
Post Construction with Vegetation

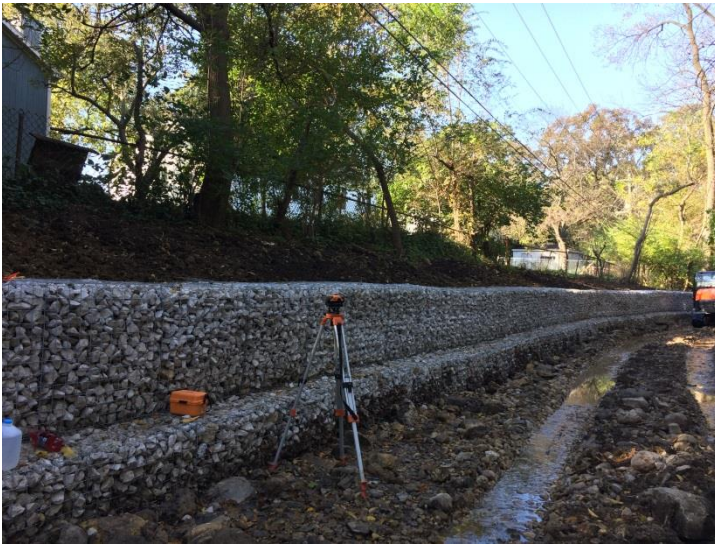
During Construction

- Wire Baskets filled with stone.
- Applicable in locations with erosion heights greater than 3 feet
- Can withstand high velocities
- Vines can be planted at top of walls to vegetate the walls.

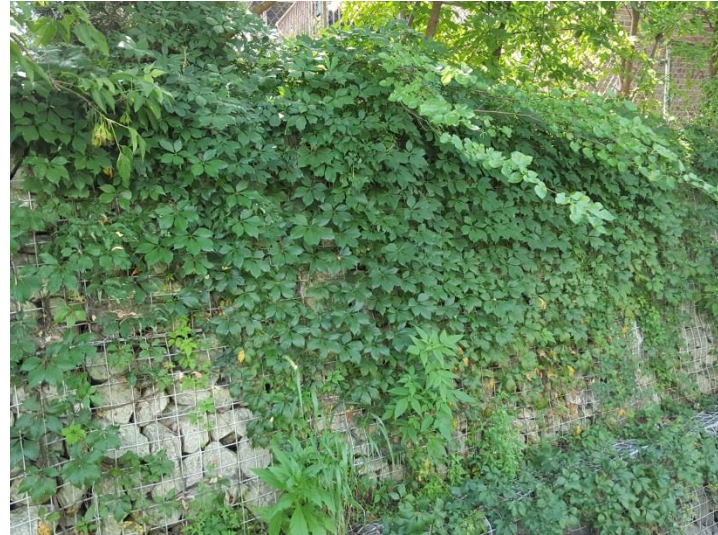
Walls can be vegetated after construction

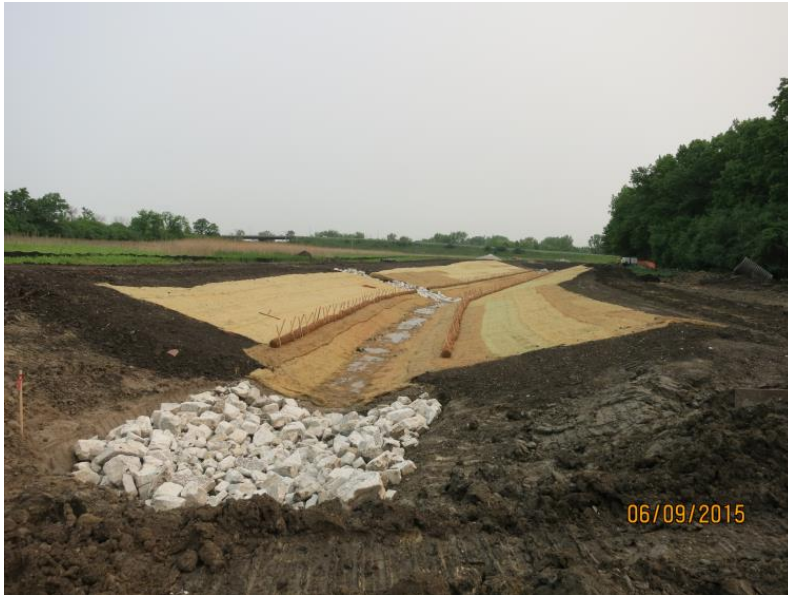
During Construction

- Eroded slopes are pulled back to provide a minimum of 3:1 side slopes.
- Slopes are stabilized with native vegetation to hold new bank.
- Minor toe protection is recommended to prevent any toe erosion.
- Requires the most land compared to gabions or soil lifts

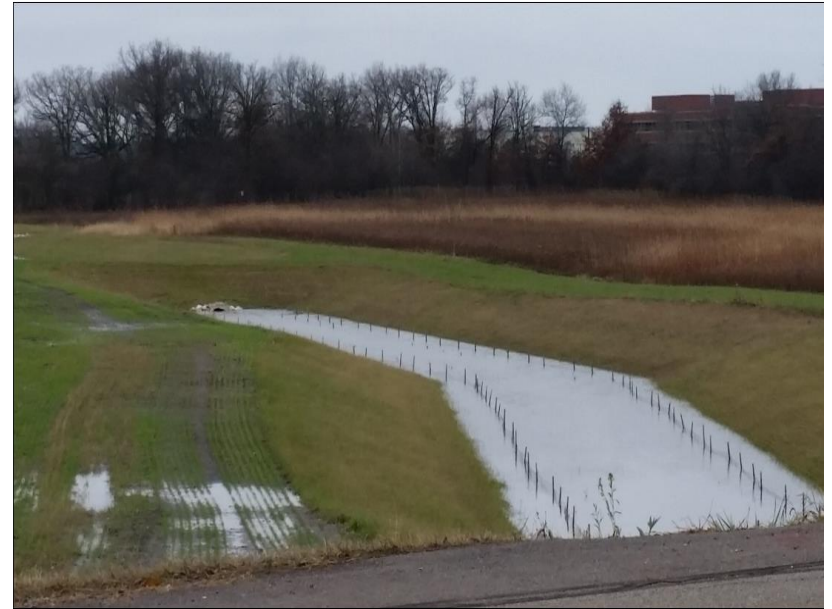
After Construction

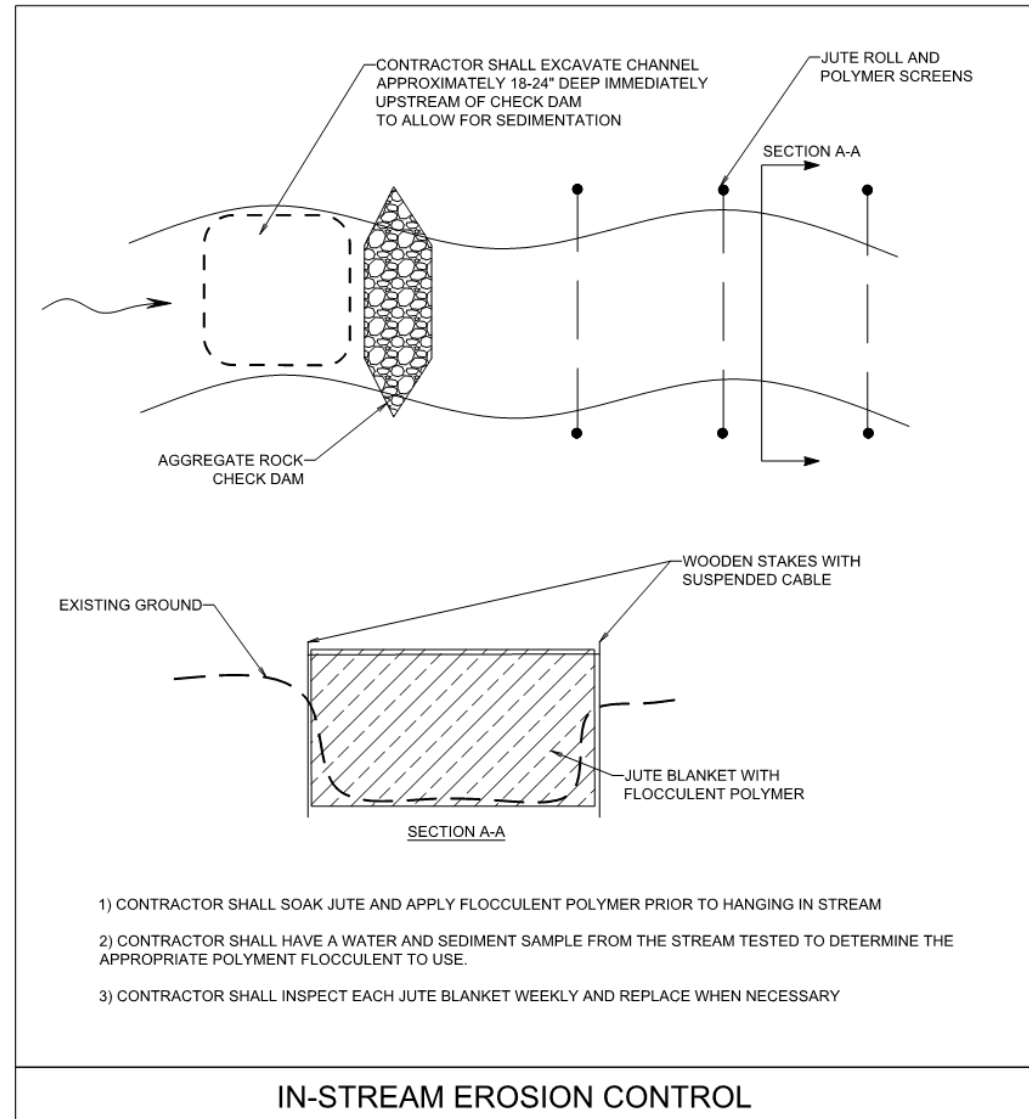
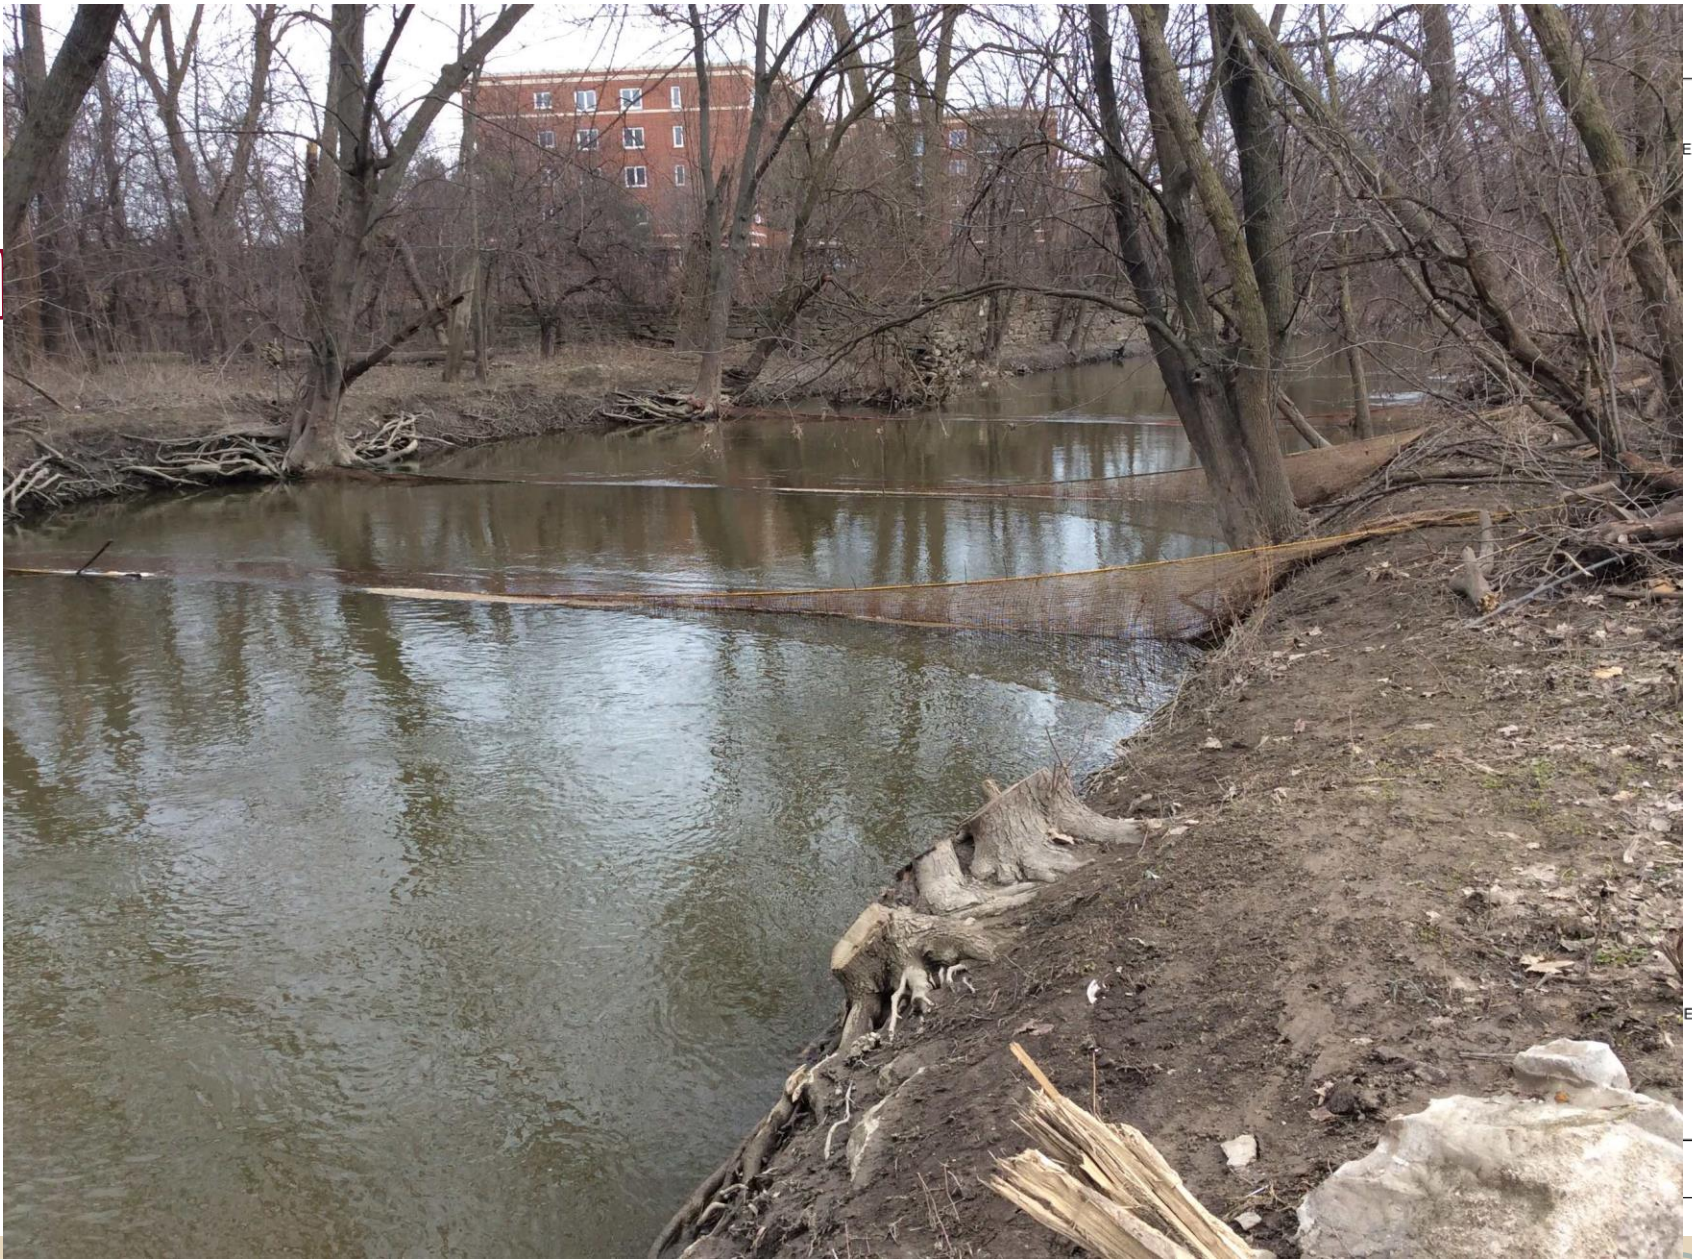
Downstream Erosion Control

- Work area will be isolated from normal flows
- Any local dewatering will run through baffle system and/or filter bags prior to re-entering waterway
- In-stream erosion control downstream →
